# Manhole Inspection Summary

Manhole # S39Q\_\_009MH

Insp Date: **10/14/08 9:41 AM**

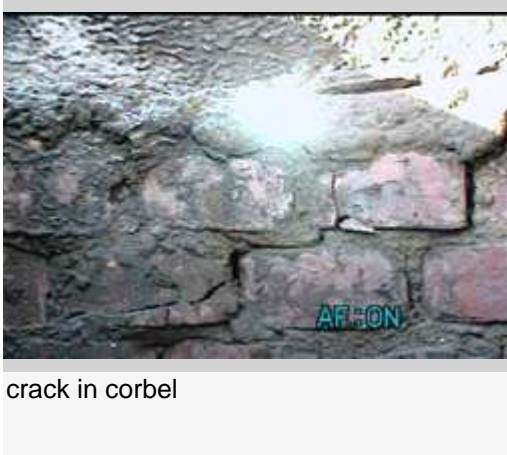
Defect 3

Condition: ☐ Sound ☒ **Cracked** ☐ Root Intrusion ☐ Loose Brick ☐ Deteriorated

crack in corbel

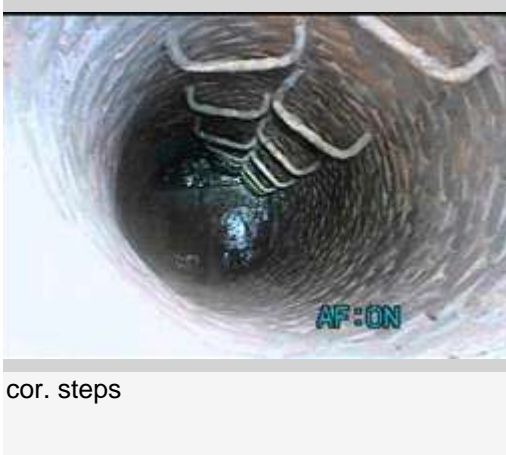
Defect 2

**Steps** Count: **15** Missing: **0** ☒ **Corroded**

cor. steps

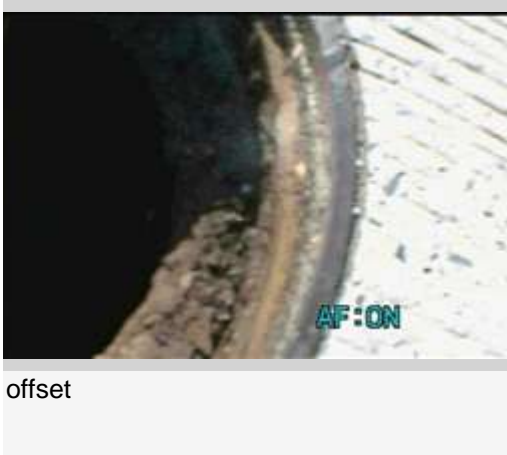
Defect 1

**Frame** Offset: **4** (in.) Condition: ☒ Sound ☐ Cracked ☐ Leaks

offset

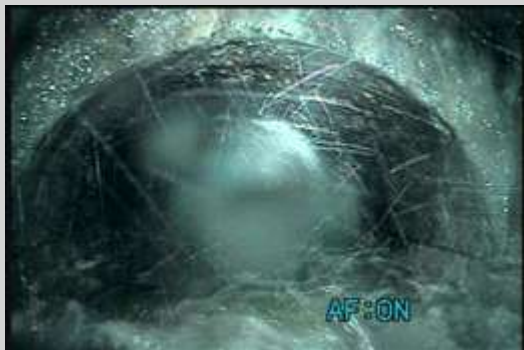
12 O'Clock Outflow

cant get better pic due to flow from pipe@9

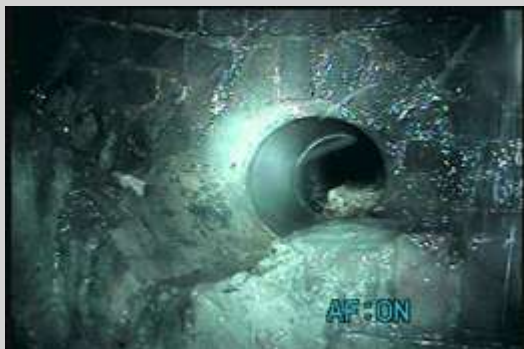
3 O'Clock Inflow

Deposits: ☐ None ☐ Mud ☐ Sludge ☒ **Debris** ☐ Grease

Silt Depth: 0 (in.) Deposits Extent: **Light**

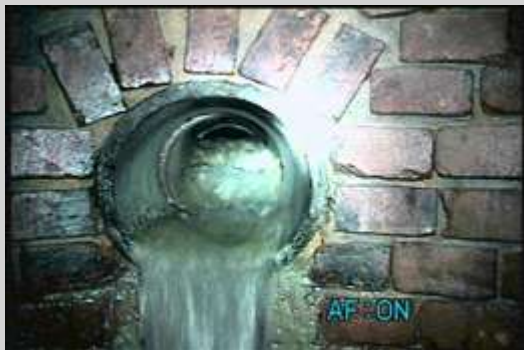
9 O'Clock Inflow

Invert Depth: **13.00** (ft.) Flow Characteristics: **Turbulent**

Deposits: ☐ None ☐ Mud ☐ Sludge ☒ **Debris** ☐ Grease

Silt Depth: 0 (in.) Deposits Extent: **Heavy**

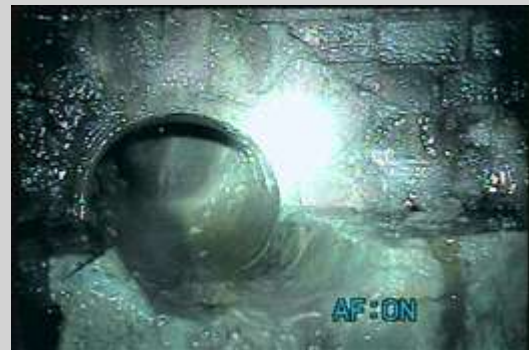
Drop In @ 9 O'Clock

Drop: **Outside Direct**

Drop Condition: **Clogged**
